2nd QUARTER LANDFILL GAS MONITORING June 2020

**Berkley Landfill
County Street
Berkley, Massachusetts
Facility #384031**

Geosyntec Consultants, Inc.
289 Great Road, Suite 202
Acton, Massachusetts

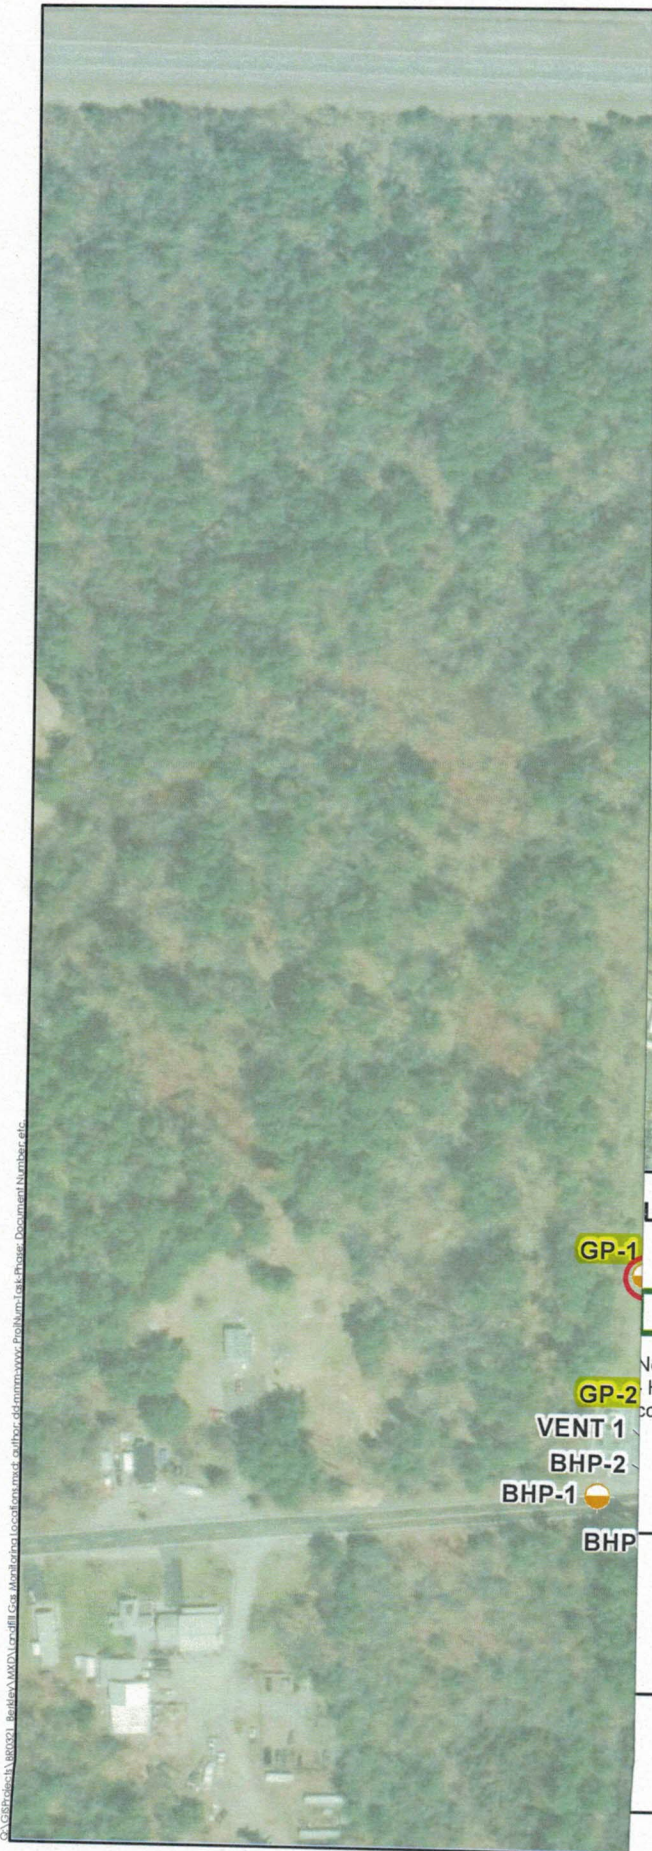
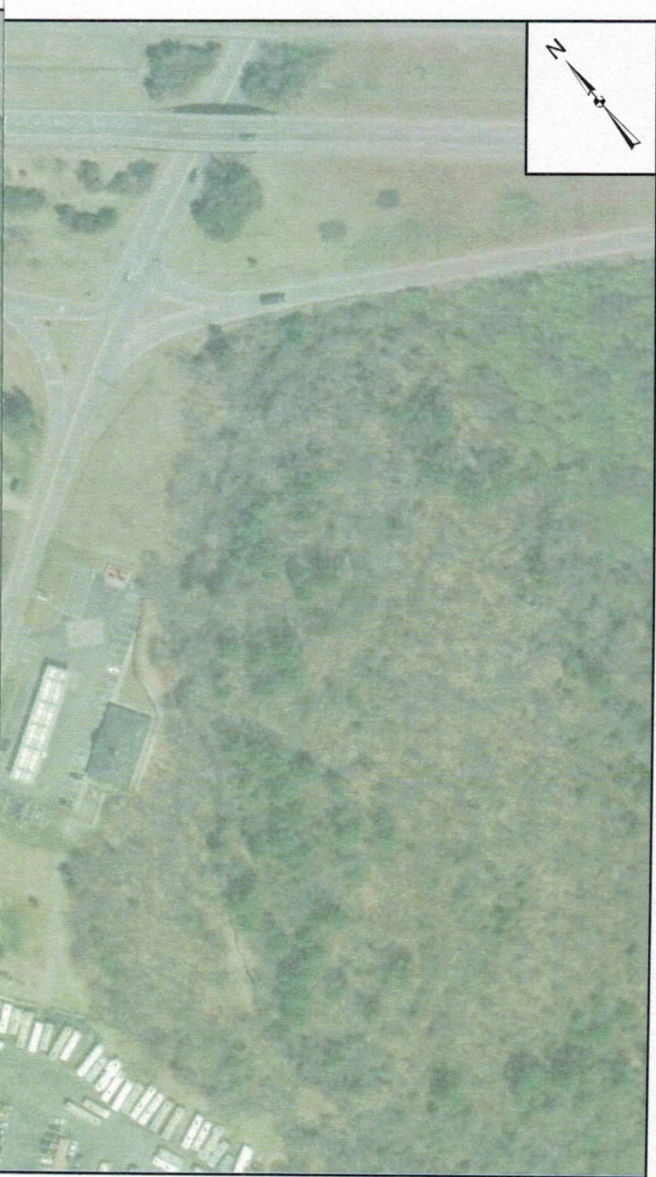
Figure
1

Methane was detected at concentrations above 25% of the LEL (LEL = 5% by volume) under steady-state conditions and initial conditions at two locations, gas probe (GP)-1 and GP-2. These locations are circled in red on Figure 1. The steady-state methane concentration detected at GP-1 was 51.2% (1,024% of LEL) and at GP-2 was 56.2% (1,124% of LEL). The initial methane concentration detected at GP-1 was 51.2% (1,024% of LEL) and at GP-2 was 56.3% (1,126% of LEL).

Note:
Highlighted and circled locations indicate an observed methane concentration greater than 25% of the LEL on June 16, 2020.

Landfill Gas Monitoring Locations
